DEPARTMENT OF TRANSPORTATION**DIVISION OF ENGINEERING SERVICES**

Contract #: 04-0120F4Cty: SF/ALA Rte: 80 PM: 13.2/13.9File #: 69.28**WELDING INSPECTION REPORT****Resident Engineer:**Pursell, Gary**Address:** 333 Burma Road**City:** Oakland, CA 94607**Report No:** WIR-002502**Date Inspected:** 10-May-2008**Project Name:** SAS Superstructure**OSM Arrival Time:** 1400**Prime Contractor:** American Bridge/Fluor Enterprises, a JV**OSM Departure Time:** 2230**Contractor:** Zhenhua Port Machinery Company, Ltd (ZPMC), Changxing Island **Location:** Shanghai, China**CWI Name:** Zhao Chen Sun**CWI Present:** Yes No**Inspected CWI report:** Yes No N/A**Rod Oven in Use:** Yes No N/A**Electrode to specification:** Yes No N/A**Weld Procedures Followed:** Yes No N/A**Qualified Welders:** Yes No N/A**Verified Joint Fit-up:** Yes No N/A**Approved Drawings:** Yes No N/A**Approved WPS:** Yes No N/A**Delayed / Cancelled:** Yes No N/A**Bridge No:** 34-0006**Component:** OBG/Tower**Summary of Items Observed:**

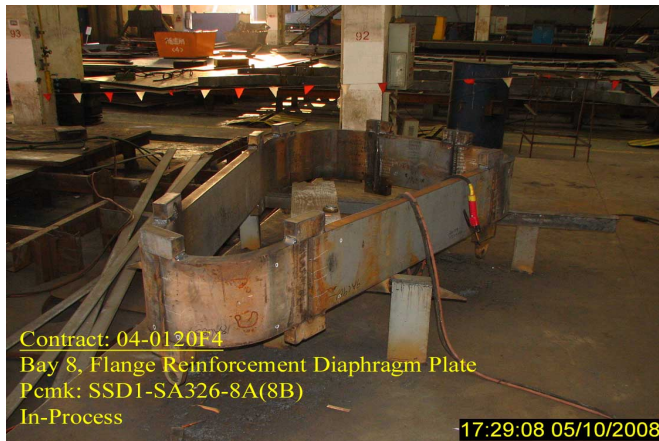
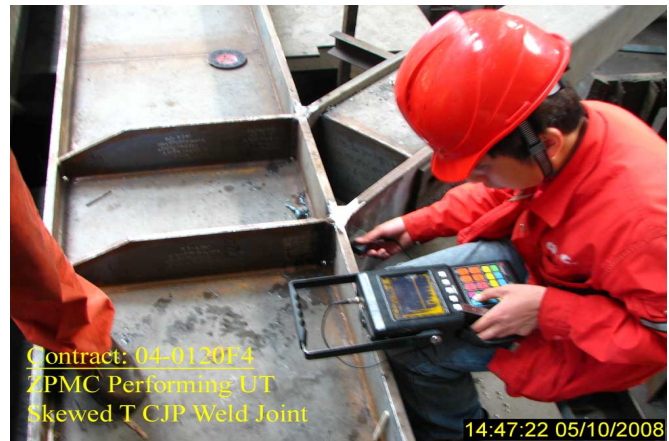
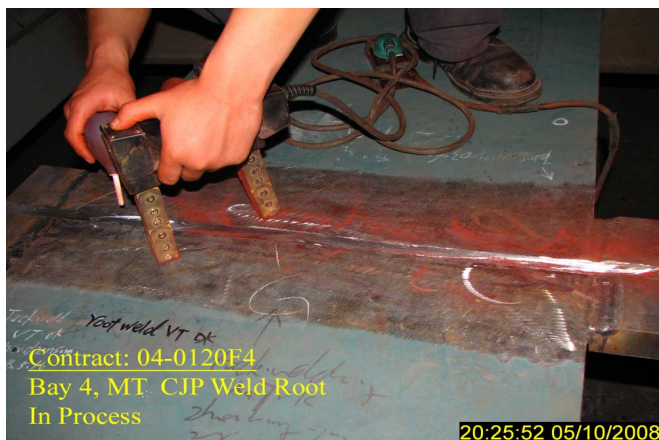
The following pictures below detail some of the work in progress on this date.
